DISASTER RISK REDUCTION APPLIED TO CANADIAN RESIDENTIAL HOUSING:

INTERIM REPORT ON THE *HOME FLOOD* *PROTECTION PROGRAM*

DR. BLAIR FELTMATE, CHERYL EVANS, NATALIA MOUDRAK | INTACT CENTRE ON CLIMATE ADAPTATION | NOVEMBER 2017

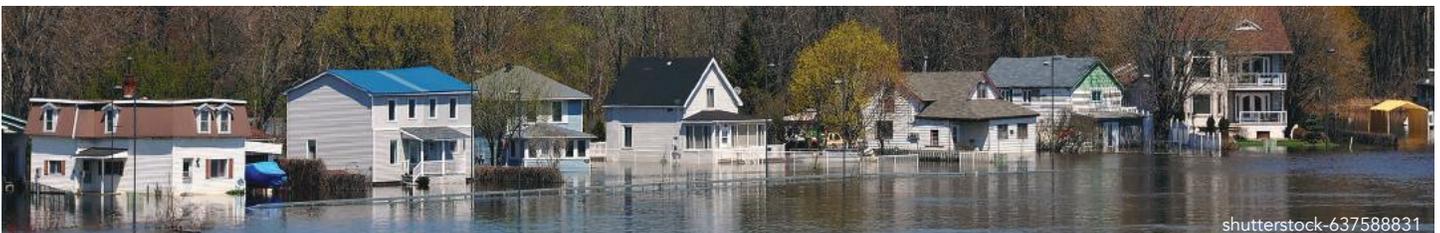
Figure 1: Key Aspects of the Home Flood Protection Program (HFPP)

Types of flood hazards addressed through the HFPP include:

- overland flooding
- storm and sanitary sewer surcharge (sewer backup)
- infiltration flooding (groundwater seepage)

Each Home Flood Protection Assessment consists of an initial homeowner questionnaire that confirms previous flood history of the assessed property, the year of construction and actions taken to reduce flood risk.

Following the initial questionnaire, flood risks inside and outside the property are assessed through a combination of visual inspections and series of standardized questions directed to the homeowner. Key features assessed are noted below, with maintenance questions that accompany each feature.

The HFPP offers homeowners a customized flood-risk assessment that addresses over 50 potential ways that water might enter into their home and cause flood damage (see *Figure 1 on page 7*). Based on the in-person assessment – which generally requires 1.5 hours – actions that homeowners can take to reduce flood risk are prioritized in a user-friendly report. This report also provides a list of standard questions that home owners should discuss with their insurance broker regarding flood coverage. Homeowners may opt in to receive seasonal maintenance reminders to help reduce flood risk around the house on an ongoing basis.

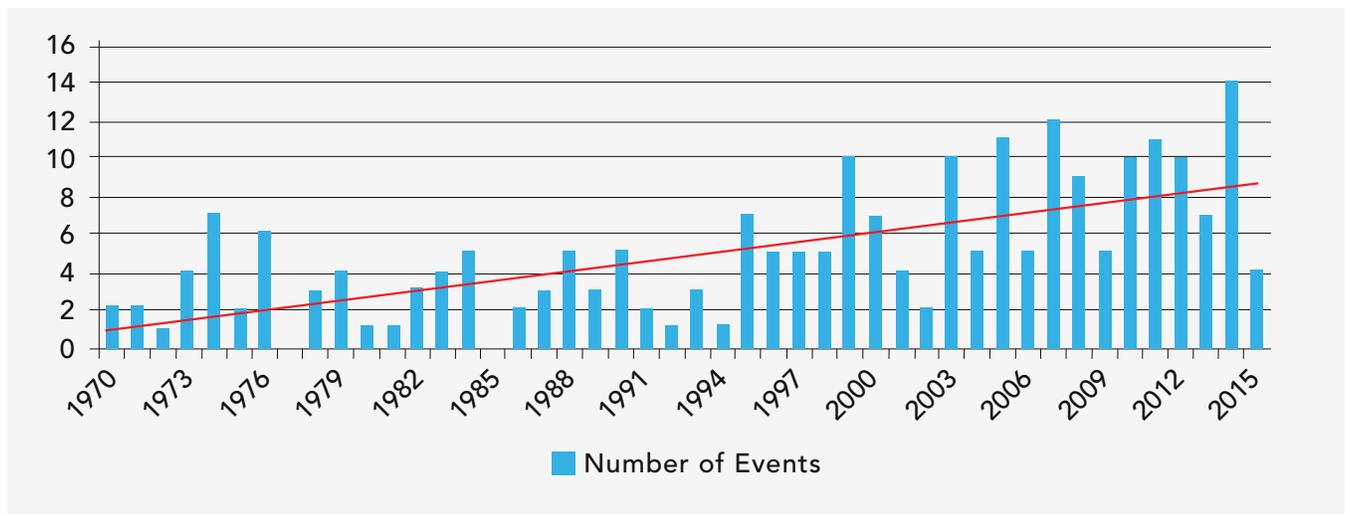
Figure 2: Number of Natural Disasters in Canada Requiring Disaster Financial Assistance Arrangements for Provinces and Territories (1970 to 2015)

The impacts of extreme weather events are bearing ever-increasing costs to governments, insurers and, by extension, all Canadiansⁱ. According to Public Safety Canada, the number of natural disasters for which provinces and territories required and obtained federal assistance under the Disaster Financial Assistance Arrangements (DFAA) increased dramatically between 1970 and 2015 (see Figure 2).ⁱⁱ Similarly, the Office of the Auditor General of Canada has noted that from 2009 to 2015, DFAA's compensation to provinces and territories was greater than any of the previous 39 fiscal years combined.ⁱⁱⁱ The DFAA's spending on flooding accounted for 75 percent of all weather-related expenditures.^{iv}

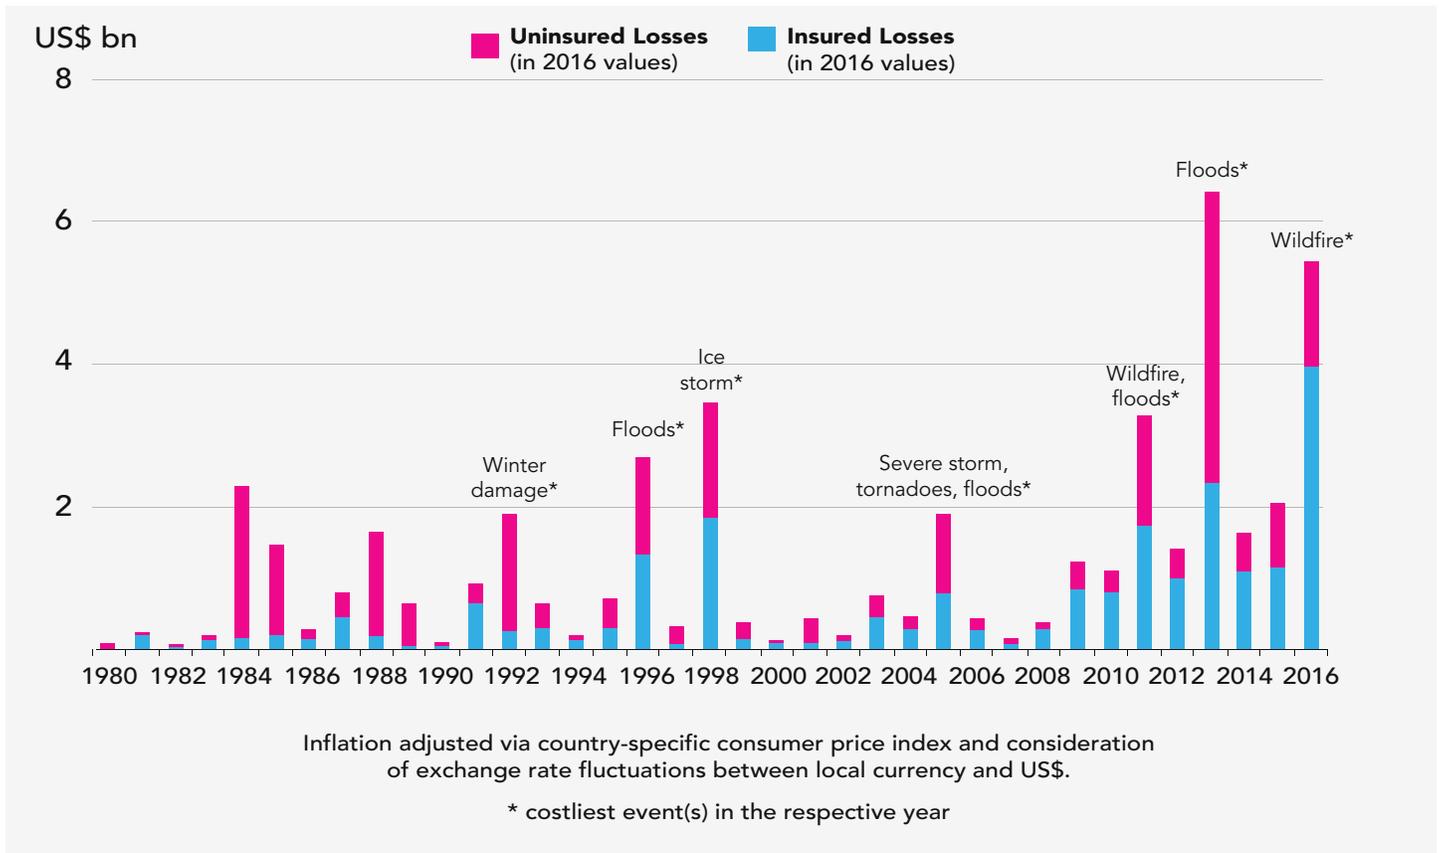
Figure 3: Catastrophic Insured Losses in Canada (1980 –2016): Overall and Insured, 2016 \$ USD

Catastrophic insurable losses for the property and casualty insurance sector in Canada are also on the rise. According to the Insurance Bureau of Canada (IBC), "property and casualty insurance payouts from extreme weather have more than doubled every five to 10 years since the 1980s."^v While insurable payouts averaged \$400 million per year over the period of 1983 to 2008, for the last seven of eight years leading up to 2016, extreme insurance payouts exceeded \$1 billion in Canada. As shown in Figure 3, the insurance gap in Canada is significant: for every dollar of insured losses in Canada, there are three to four dollars of uninsured losses that are borne by government, homeowners and businesses across the country.

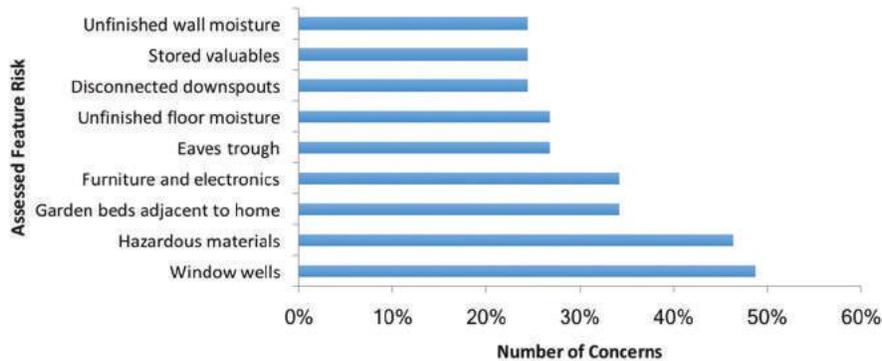
Figure 7: Top Assessed Flood Risk Features Identified

•Top flood issues identified through HFPP Assessments: The most common flood issues identified through HFPP Assessments in Burlington included:

- improperly installed or inadequate window wells (50% of assessed properties);
 - presence of unsecured hazardous materials stored on basement floors (47% of assessed properties);
 - presence of furniture and electronics susceptible to water damage in the basement (35% of assessed properties);
 - poor grading of garden beds located outside homes (35% of assessed properties);
 - high levels of moisture on basement floors (25% of assessed properties); and
 - downspouts depositing water less than 1m from the foundation (25% of assessed properties).
- See Figure 7 for the top assessed flood risk features identified.

- **Most common flood risk challenges:** Based on completed assessments in Burlington, the most common flood risk challenges include:
 - improperly installed or inadequate window wells (issue documented for 50% of assessed properties);

- presence of unsecured hazardous materials - paints, aerosols and corrosive substances - stored on basement floors (issue documented for 47% of assessed properties);

- presence of furniture and electronics susceptible to water damage in the basement (issue documented for 35% of assessed properties);
 - poor grading of garden beds located outside homes (issue documented for 35% of assessed properties);

- high levels of moisture on basement floors (issue documented for 25% of assessed properties); and
- downspouts depositing water less than 1m from the foundation (issue documented for 25% of assessed properties).

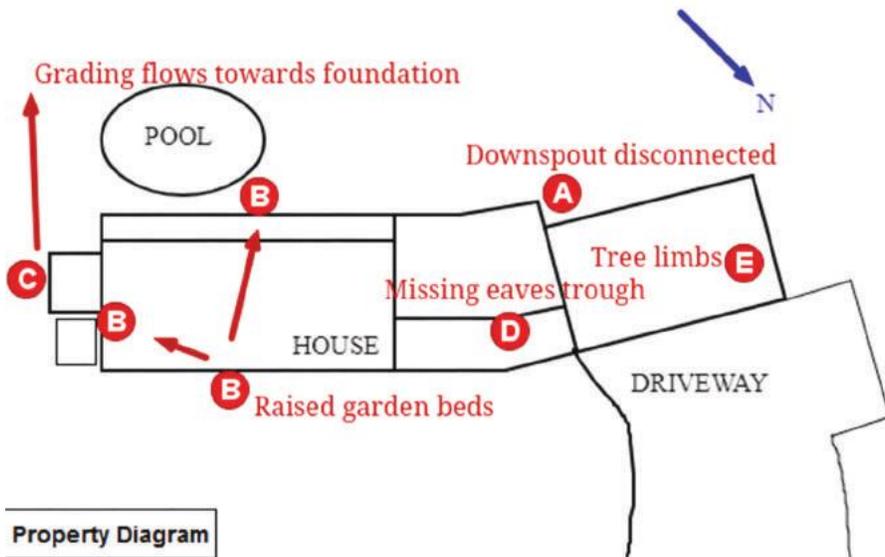
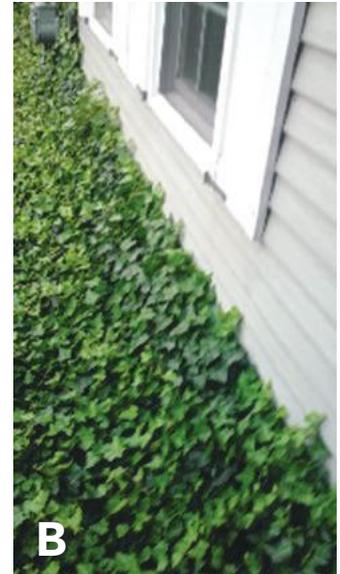
Property Diagram

All features and maintenance practices that were assessed as “poor/ needs further investigation”, require specific mention based on questions asked by the homeowner or are marked as “out of scope” but deserve further consideration, have been compiled into this summary.

Fig	Assessed Feature Description	Type of Water Damage	Challenge	Opportunity to Reduce Risk
	Condition of trees- Do trees pose any property damage risk or flood risk? Healthy and well pruned trees whose limbs do not hang over buildings and hydro lines reduce property damage risk during extreme weather events. Trees planted too close to foundations or sewer lines pose a risk of root damage and can contribute to flood risk.	SB, WS, GS	Trees appear to be in poor condition./ Many tree limbs hang over the home, driveway or hydro lines./ The position of trees represent high risk to the home's foundation or sewer lateral.	See E on Outside Assessment diagram. Some large tree limbs are hanging over the garage and pose damage risk during significant wind and ice storms. Consider contacting a certified arborist to assess tree health and prune as required.
B	Garden beds adjacent to home - Do garden beds and foundation plantings pose risk of infiltration of water into the basement or limit drying potential of foundation? Garden beds adjacent to the home's foundation pose a risk of infiltration of water into the basement unless soil is graded at least 5% away from foundation, soil and mulch are less than 8" from top of foundation. Trees that will reach a height of 30'(10m) or more are a minimum of 15' (5m) from foundations and shrubs are minimum of 6' (2m) from foundations. Dense plantings close to foundation limit drying potential of foundation and present increased risk of foundation deterioration.	GS	Foundation plantings provide poor light and air circulation between plantings and foundation. Less than 8" of foundation remains exposed. Trees that will reach height of 30'(10m) or are closer than 12'(4m) from foundation and shrubs are closer than 3'(1m) from foundation. The garden bed has less than 2-3% slope away from the foundation and water drains poorly away from the foundation.	See B on Outside Assessment diagram. Heavily prune back plantings to improve light and air circulation. Remove plantings that are too close to foundation. Correct grade to minimum 5% slope to ensure water flows away from foundation.

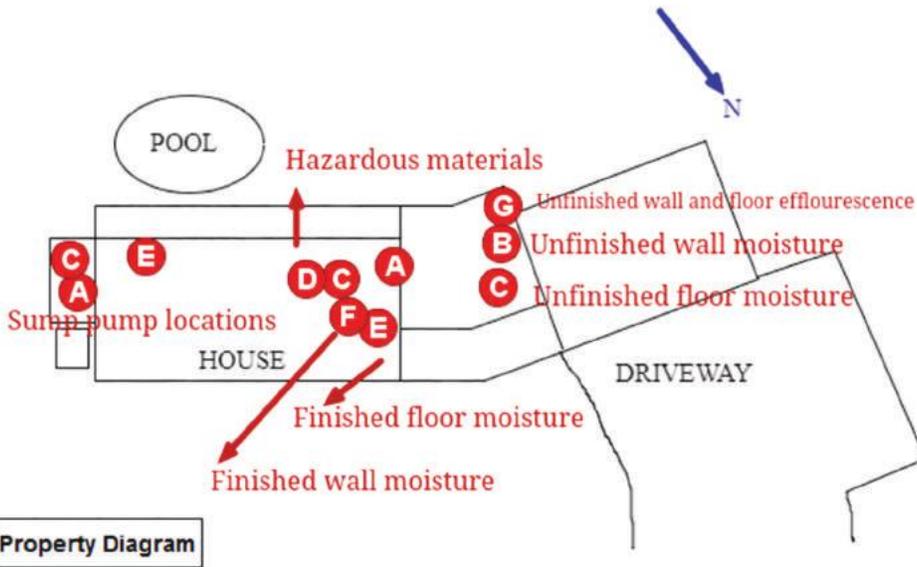
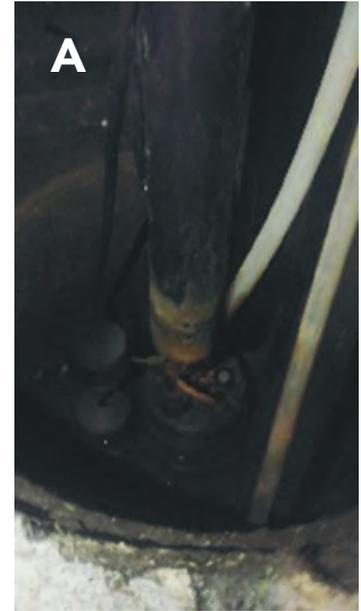
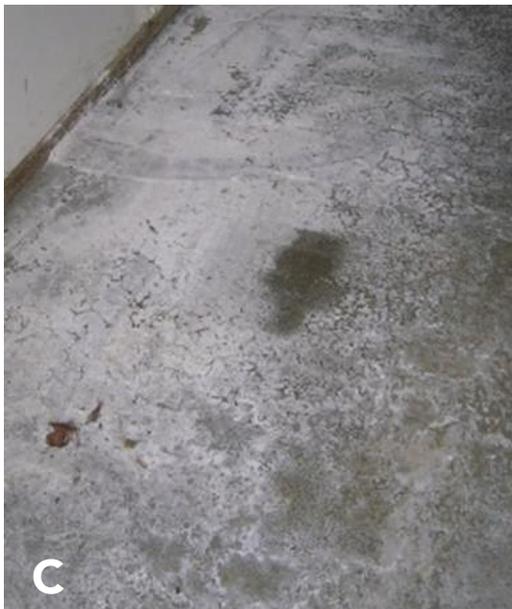
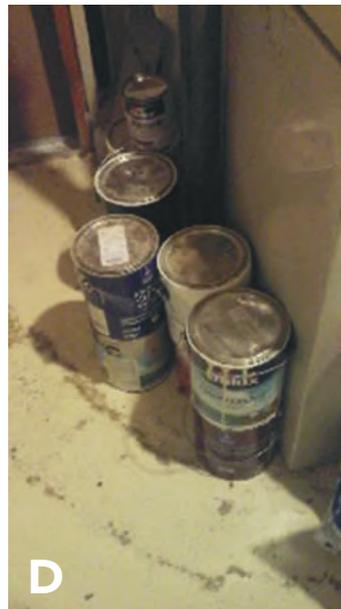
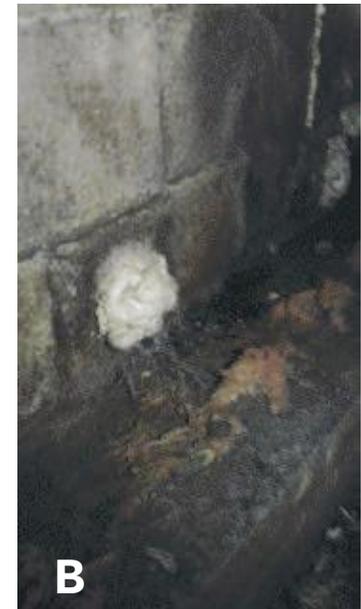
Property Diagram

All features and maintenance practices that were assessed as "poor/ needs further investigation", require specific mention based on questions asked by the homeowner or are marked as "out of scope" but deserve further consideration, have been compiled into this summary.

Fig	Assessed Feature Description	Type of Water Damage	Challenge	Opportunity to Reduce Risk
	<p>Foundation drain- Is a foundation drain (weepers) present? If so, is it functioning properly to drain water away from your foundation? Depending on the age of your house it may or may not have a foundation drain or it may have a drain that is old and in poor condition. Missing or clogged drains increase the risk of basement infiltration flooding. Foundation drains that are connected to sanitary or storm sewers increase the risk of sewer backup related flooding. Note: Foundation drains are not common before 1950. Determining the condition of the foundation drain is outside of scope of this assessment. Consult a qualified professional.</p>	<p>GS, OW, SB</p>	<p>Note: Only a qualified professional can formally identify the condition of this item or recommend if one would be right for your home. Note: Check with the Region regarding eligibility for subsidy.</p>	<p>Your home is over 40 years old. A damaged or collapsed foundation drain is a possible source of high levels of water infiltration at your home. Consider working with a qualified professional to assess and repair your foundation drain if necessary to ensure that water is efficiently collected from your foundation and sent to your sump pit.</p>
